Department of Lands and Natural Resources
Outer Cove Marina

**OPA Report No.
AR-15-03**

RE: REPORT ON THE AUDIT OF THE OUTER COVE MARINA

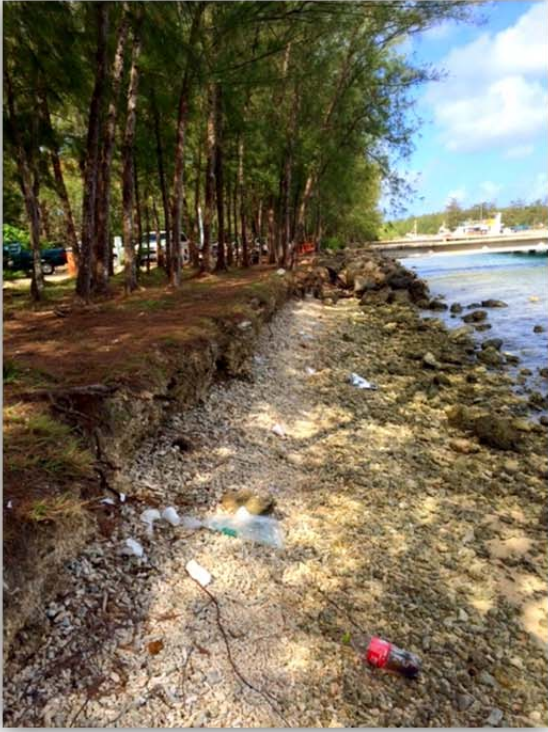
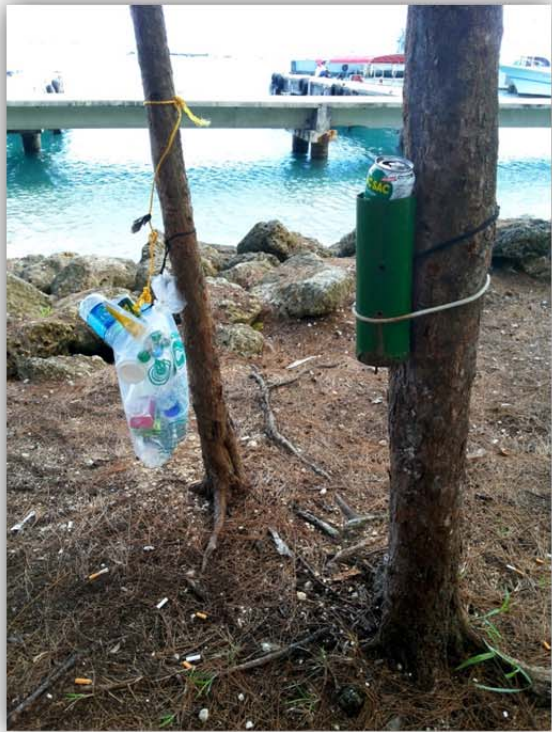
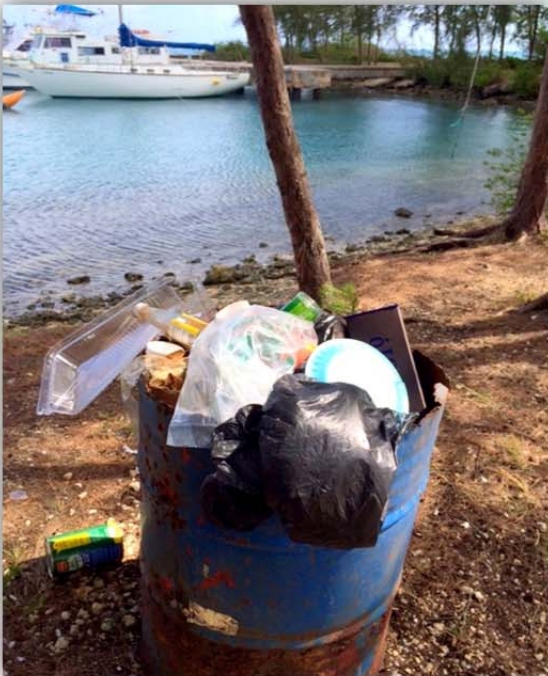
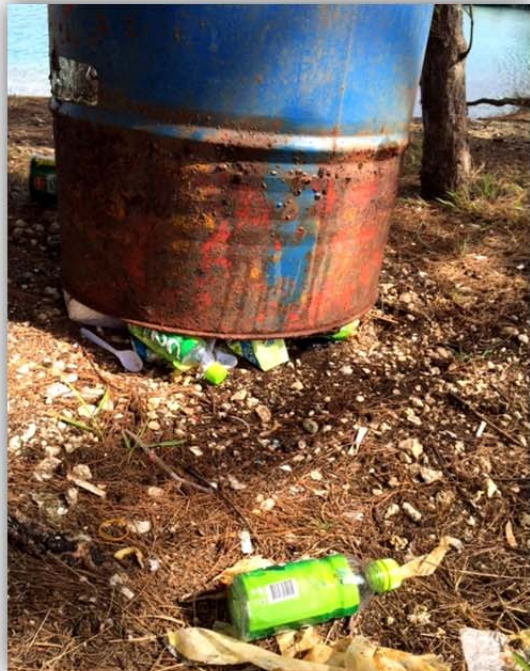
Exhibit 11

- (b) *OCM lacks the basic amenities.* The marina lacks running water, trash receptacles, sewage pump-out station, and restrooms. Garbage bins are not in evidence and barrels used for this purpose often lack watertight construction. Littering is prohibited both by law and by Regulations, yet trash is common, left by both passengers and other users of the OCM. Furthermore, sanitary conditions threaten the lagoon environment both from human effluent and from leaching of garbage into the lagoon waters. (*See Appendix E, Exhibit 11*).

Recommendation: DLNR must enforce its own Regulations and conduct the operations of OCM in a safe, professional, and business-like manner. Furthermore, DLNR should

find the necessary funds to provide, at the very least, basic amenities for users of the marina.
